MARYLAND INVENTORY OF HISTORIC BRIDGES HISTORIC BRIDGE INVENTORY MARYLAND STATE HIGHWAY ADMINISTRATION/MARYLAND HISTORICAL TRUST

MHT No. <u>BA-2857</u>

SHA Bridge No. 3012 Bridge	e name MD 7 over Little	e Gunpowder Falls (L	ittle Gunpowder Bridge)
LOCATION: Street/Road name and numl	per [facility carried] <u>N</u>	MD 7 (Philadelphia R	doad)
City/town Bradshaw		Vicinity	X
County Baltimore	······		·
This bridge projects over: I	Road Railway	Water	X Land
Ownership: State X	County	Municipal	Other
		ional Register-detern	nined-eligible district
Name of district		The Walter Constitution of the Constitution of	
BRIDGE TYPE: Timber Bridge: Beam Bridge: Stone Arch Bridge: Metal Truss Bridge	_ _	Trestle Ti	mber-And-Concrete
Movable Bridge: Swing: Vertical Lift Metal Girder Rolled Girder	Retractile	Pontoo Concrete Encased	
Plate Girder Metal Suspension		oncrete Encased	
Metal Arch			
Metal Cantilever	_		
Concrete X : Concrete Arch X Other Type Nam	Concrete Slab	Concrete Beam	_ Rigid Frame

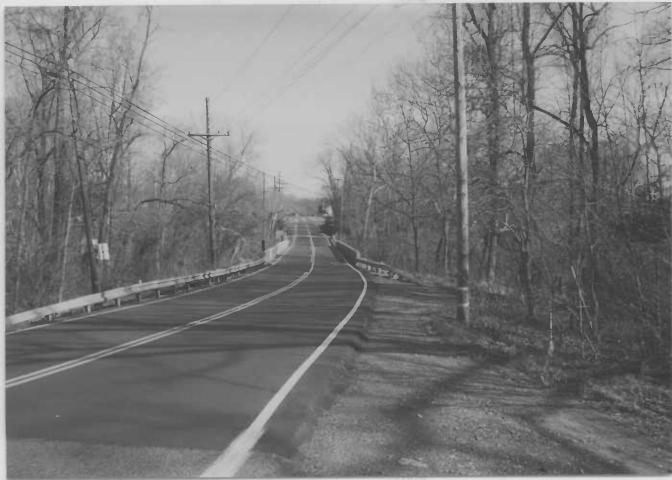
Inventory # <u>2A-2857</u>

County/State BALTII	MORE COUNTY/MD DAVE DIEHL
Date 195	
Location of Negative	SHA
Description WEST	APPROACH WOILING
EAST	•

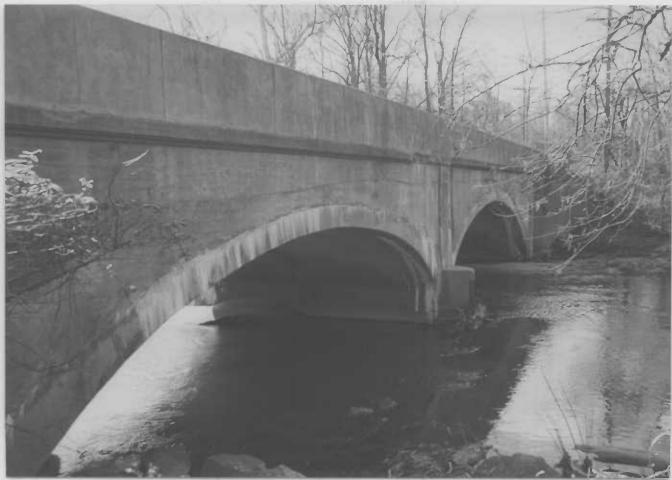
Inventory # BA-2857

Description NORTH ELEVATION LOOKING SOUTH WEST

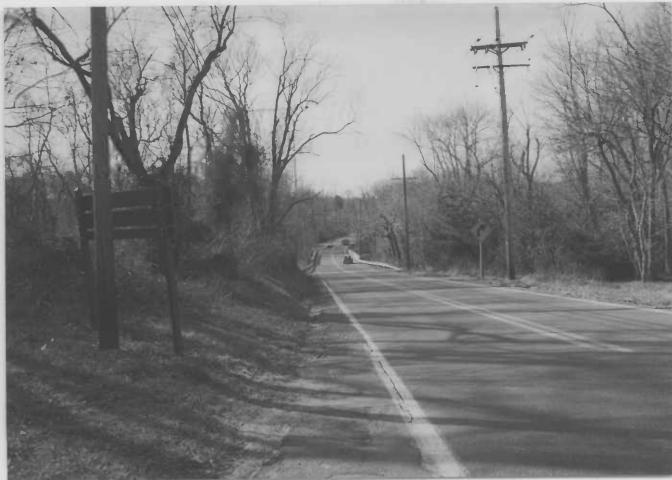
Inventory	#	BA-2857

Description EAST APPRDACH WOKING WEST
